**PRELIMINARY ASSESSMENT/
VISUAL SITE INSPECTION**

**MIDLAND ROSS CORPORATION
TOLEDO, OHIO
OHD 097 232 946**

FINAL REPORT

**U.S. ENVIRONMENTAL PROTECTION AGENCY
Office of Waste Programs Enforcement
Washington, DC 20460**

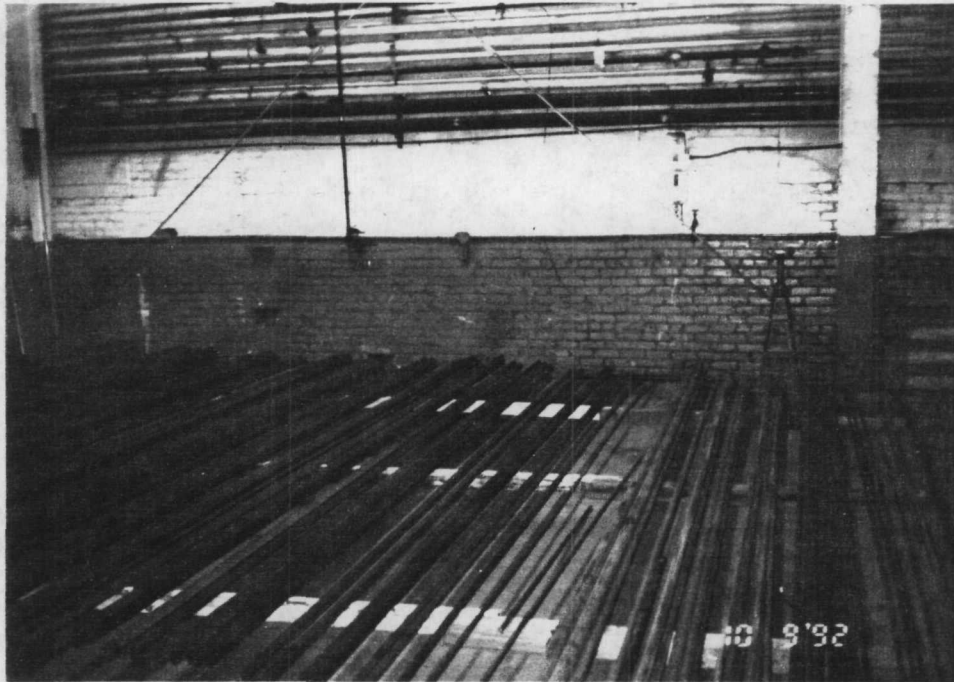
Photograph No. 1

No floor drains, cracks, or stains were observed on the concrete floor during the VSI (see photograph number 1).

Location: SWMU 1

Recommendations: PRC recommends no further action at this time.

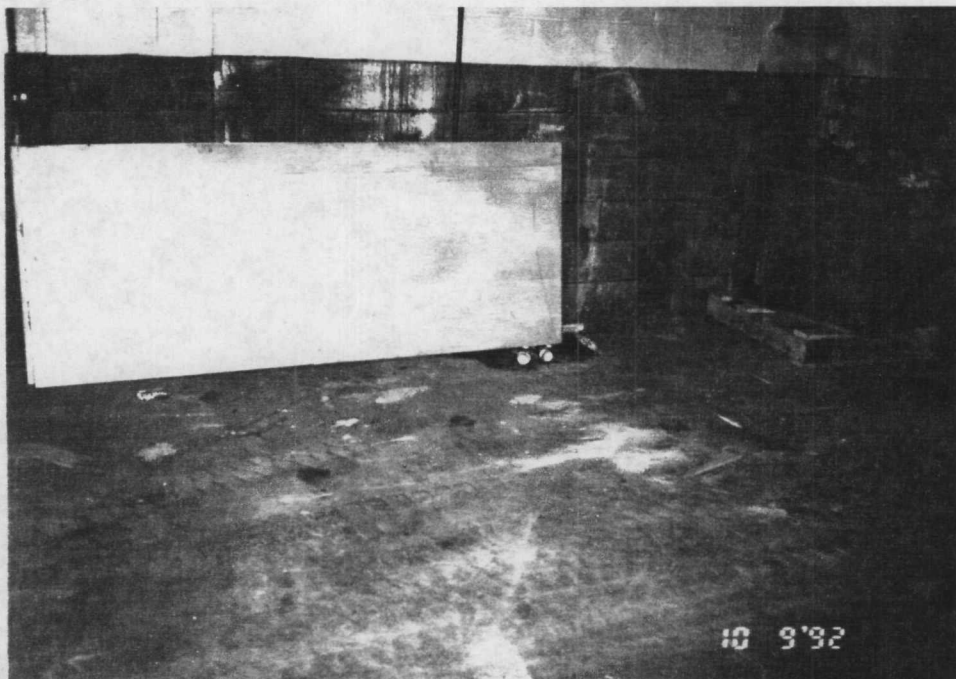
Photograph No. 2

Observations:	No floor drains, cracks, or stains were observed on the concrete floor during the VSI (see photograph number 2).
SWMU 3	Outdoor Container Storage Unit
Unit Description:	This SWMU is the northwest corner of the asphalt parking lot located east of the North Westwood Avenue buildings. This SWMU is 10 feet by 100 feet and is located a few feet south of the northern property line. Its long axis is oriented east-west.
Date of Startup:	The startup date of this SWMU is unknown.
Date of Closure:	No documentation addressing closure of this unit was available for this report. Photographs showing the presence of drums at this SWMU are included in a Phase I Assessment by ECI for Giant Products Corporation dated August 1990. No drums were observed during the VSI.
Wastes Managed:	Unknown. Photographs included in the Phase I Assessment show some 55-gallon drums with square, yellow labels that are indicative of drums containing hazardous waste.

Location: SWMU 2

PRC recommends a closure equivalency demonstration be performed.

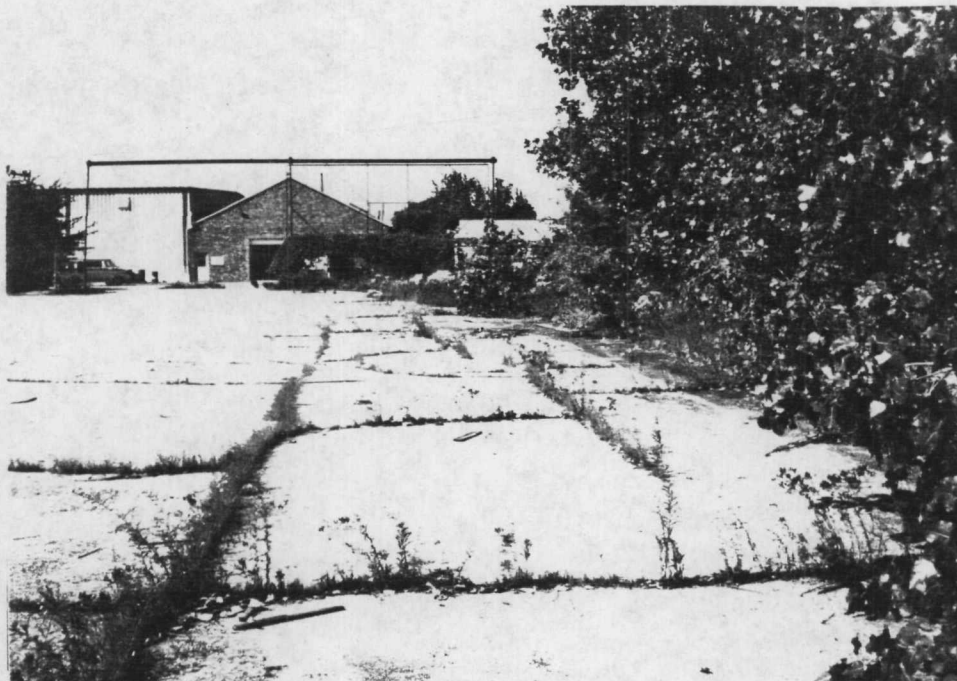
Photograph No. 3

Release Controls:	This SWMU has an asphalt surface, but cracks in the asphalt are evident.

Observations: The asphalt surface possessed several cracks with vegetative growth during the VSI (see photograph number 3).

time of the VSI, the asphalt surface of this SWMU possessed moderate sized cracks exposing soil. Though the cracks may have increased in width in the last two years, the cracks probably existed at the time the Phase I Assessment was conducted.

Location: SWMU 3

Recommendations: PRC recommends sampling the soil below the asphalt and analyzing the soil samples for heavy metals and organic solvents.

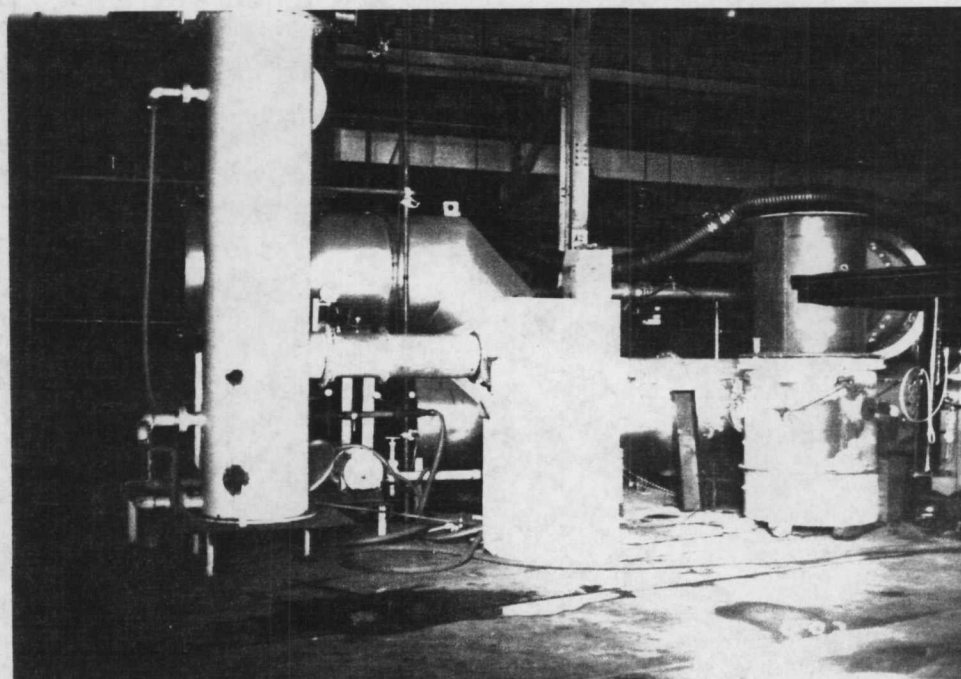
Photograph No. 4

Observations: During the VSI no floor drains were observed on the concrete floor, but minor cracks in the concrete were observed. Steel train rails are embedded into the concrete floor but are not currently utilized. No cracks existed in the concrete along the length of the rail (see photograph numbers 4 and 5).

Location: SWMU 4

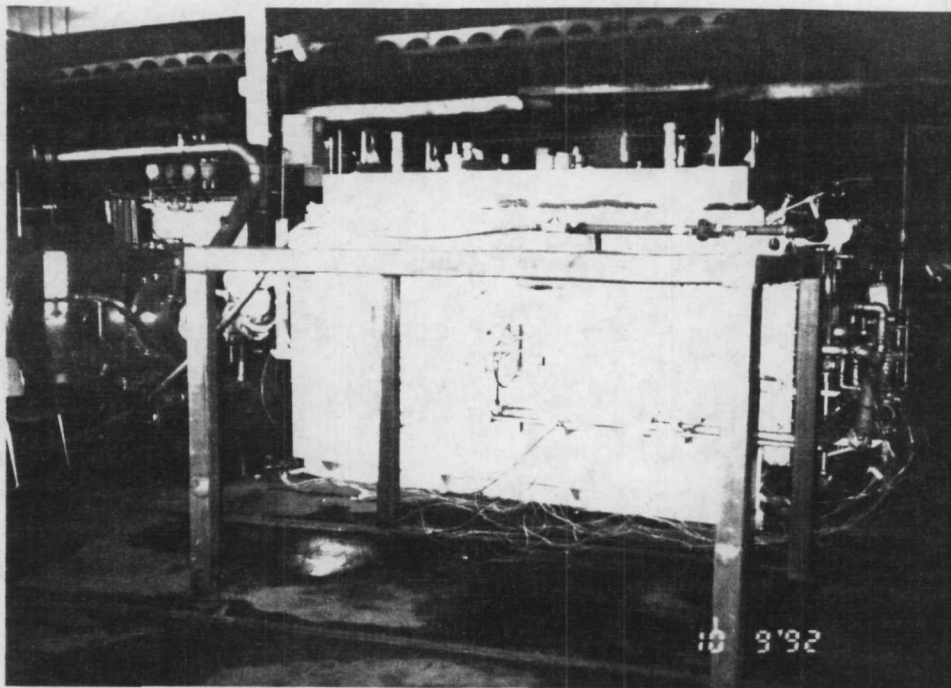
Photograph No. 5
 Orientation: West, southwest
 Description: Batch pyrolyzer of the incinerator at Dorr Street.

Location: SWMU 4
 Date: September 10, 1992

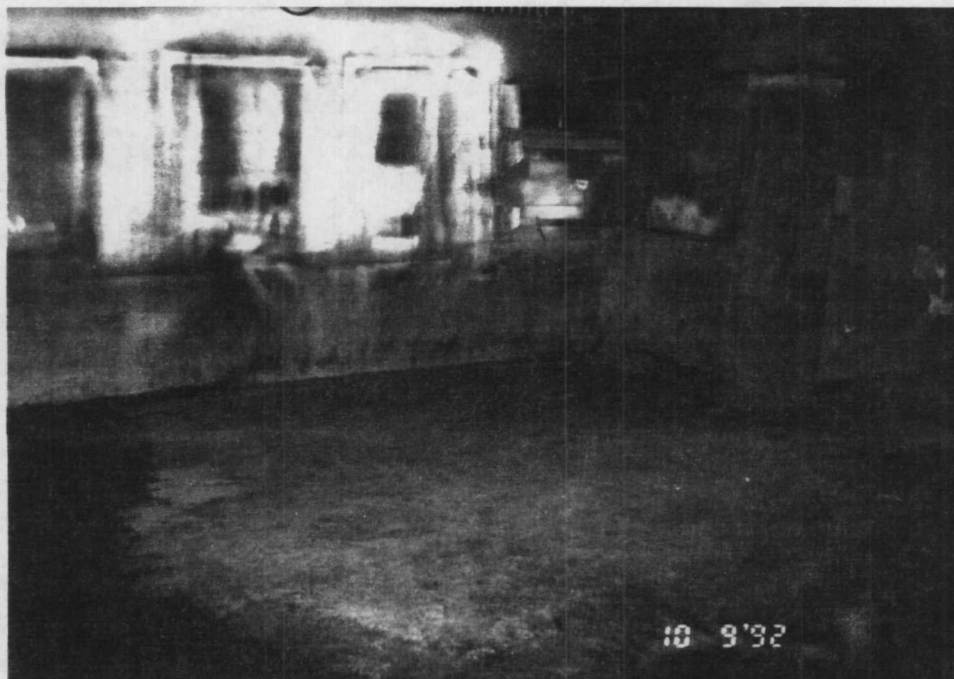
During the VSI no floor drains were observed, but the floor was covered with gray dust. A part of the south end of the room extends further south into a paint booth. In about 1990, the paint booth was operated by a tenant (whose name is not available for this report) of the current owner (J & G) of the building (see photograph number 6).

Photograph No. 6
 Orientation: Southeast
 Description: Former container storage area at Dorr Street.

Location: SWMU 5
 Date: September 10, 1992
